A STUDY OF THE
CONCRETE-FILLED STEEL GRID DECKS
IN OHIO

Donald H. Timmer, P.E.
Richland Engineering Ltd.
Mansfield, Ohio

The study was undertaken to determine the causes, types and extent of failures in concrete filled steel grid bridge decks. The study uncovered the phenomena dubbed "deck growth", that is caused by the rusting of individual steel grid I bars and is unique to filled grid decks. The increase in thickness or bulking of the I bars displaces adjacent concrete and develops compressive stresses in the concrete fill, in the cells located between I bars. In the initial stage of deck growth, the compression of the fill tends to close voids and capillaries in the concrete and decrease the amount of moisture that can reach the rusting surfaces. The resulting slow down or halting of deck growth is another phenomena dubbed "stress balance." If deck growth continues beyond the initial stage, it will involve the progressive failure of the deck and will lead to the breakup of the fill and grid, a critical failure in the bridge superstructure and/or severe damage to the bridge substructure. The study includes the survey of the 60 bridges in Ohio that have, or recently have had fi

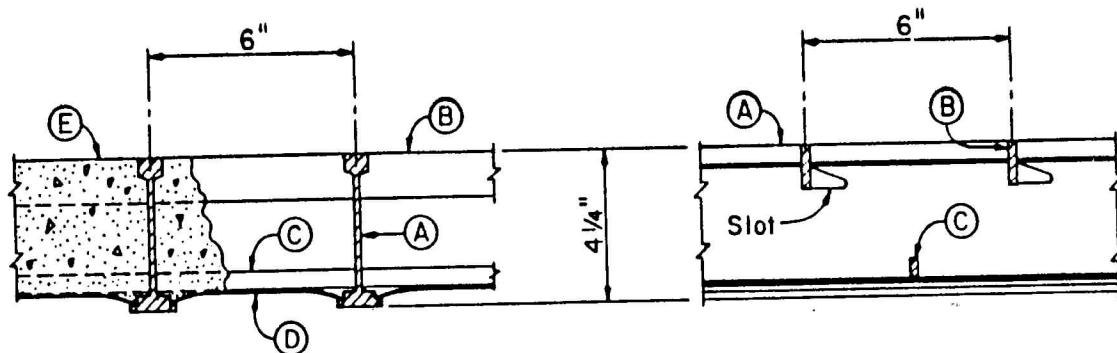
Fig. 2

are several variations in the make up and dimensions of the steel grid systems, the most commonly used feature $4\frac{1}{2}$ inches (11 cm) main I bar members, spaced on 6 inch (15 cm) centers, as shown in Figure 2. The main I bars are slotted to receive the continuous top cross bars and are drilled or punched to receive the continuous bottom cross bars (Figure 3). The cross bars are tack welded to the I bars to form grid panels that are 4 to 8 feet (1 to 2 m) wide and up to 50 feet (15 m) long.

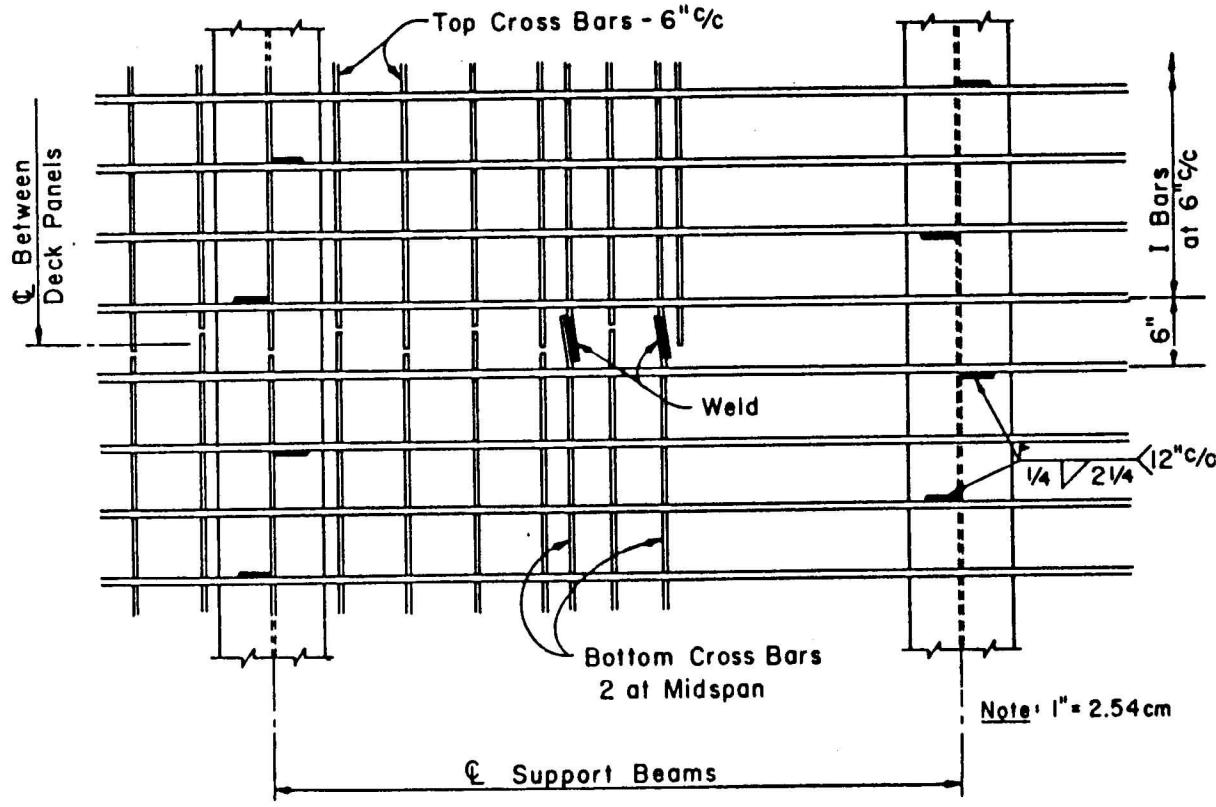
Fig. 4

The assembled steel grid panels are then transported to the bridge site and installed in the superstructure stringers or beams as shown in Figure 4. After the panels are positioned and welded to the beams, sheet metal bottom forms are installed and splices made between adjacent sections of the steel grid panels. Then the other deck items, such as drainage grates, expansion joints, curbs, etc. are installed and the concrete fill placed.

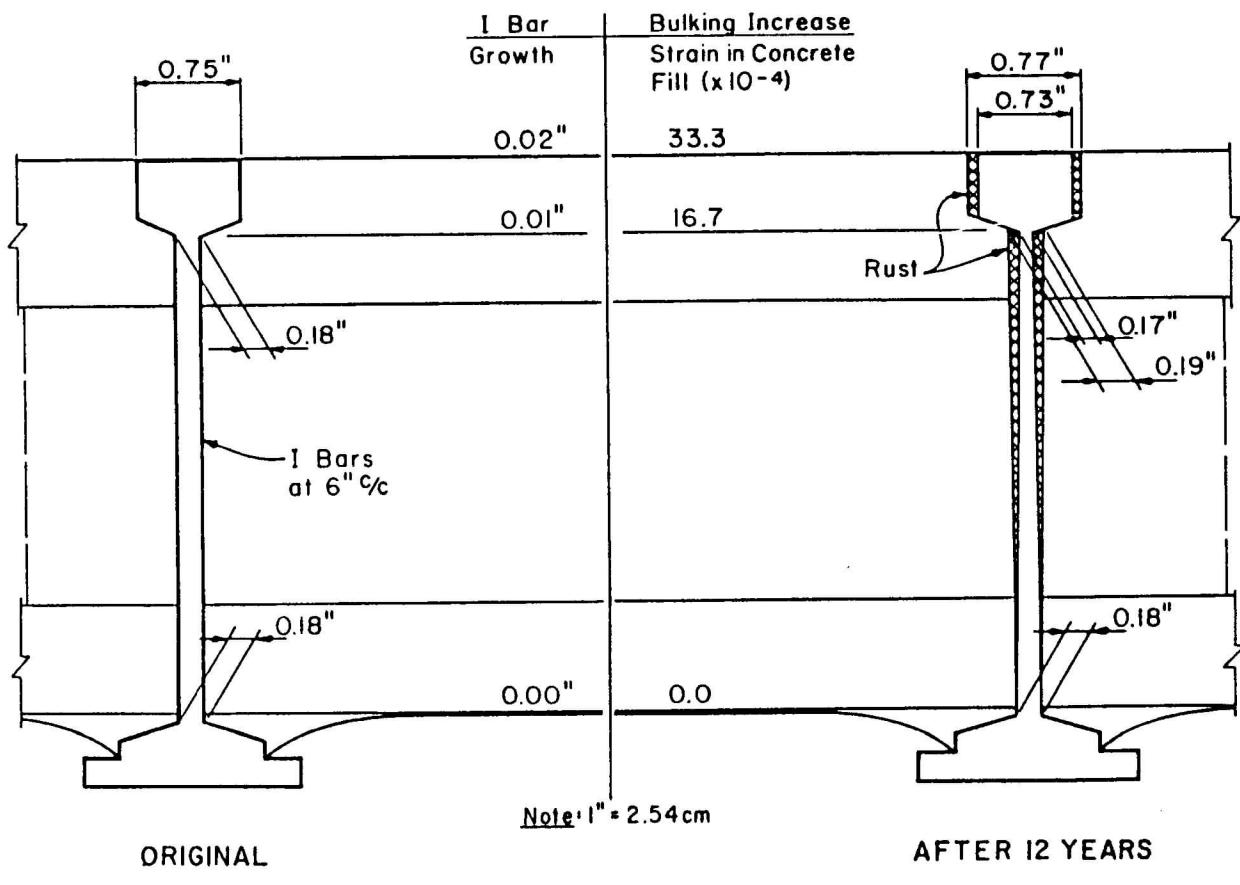
Fig. 6

Thus, the bulking or increase in thickness of the I bars is roughly equal to the thickness of metal lost (Figure 6). The bulking of the webs of the I bars, located on 6 inch (15 cm) centers, averages 0.005 inches (0.13 mm) and represents a strain of 0.00083. If the deck is free to lengthen, applying this strain to the concrete fill, will cause a deck growth of approximately one inch in 100 feet (25 mm in 30 m). If the deck is securely attached to the bridge superstructure, this strain will generate an average compressive stress of approximately 2000 psi (pounds per square inch) (14 MPa) in the fill concrete.

Figure 6. Gaylord's corrosion measurements, Bridge 25. (1975).

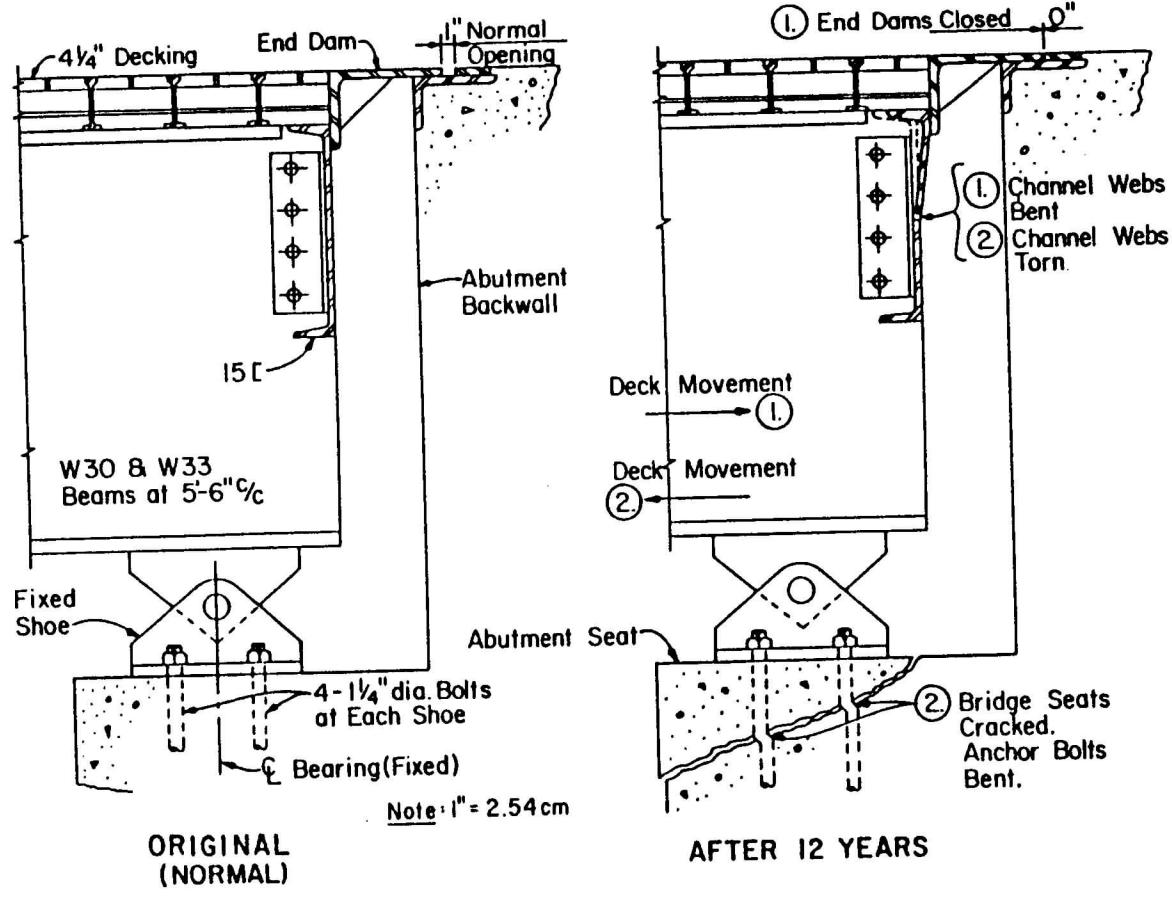
Fig. 14

Professor Gaylord's studies suggested that these forces generated a compressive stress of 125 psi (1 MPa) in the deck and 33,000# (15 Mg) in each beam, for each 0.0003 inches (.008 mm) of rust growth in the I bars. This thrust was adequate to overcome the 28,000# (13 Mg) shear developed by fillet welds that fastened the steel grid to the beams, located at the ends of deck sections. As the welds continued to break progressively along the beams, the expanding deck began to warp the tops of the end dam support channels and gradually close the end dam joints, as shown in Figure 14. After the deck joints had closed, continued expansion caused the channel

Figure 14. Damage to joint supports and bridge seats, Bridge 25. (1964).
