RAPID REDECKING

Round-the-clock schedules helped an extensive bridge deck replacement project finish a year ahead of schedule despite limited lane closure requirements.

RANDY PICKLE, P.E.

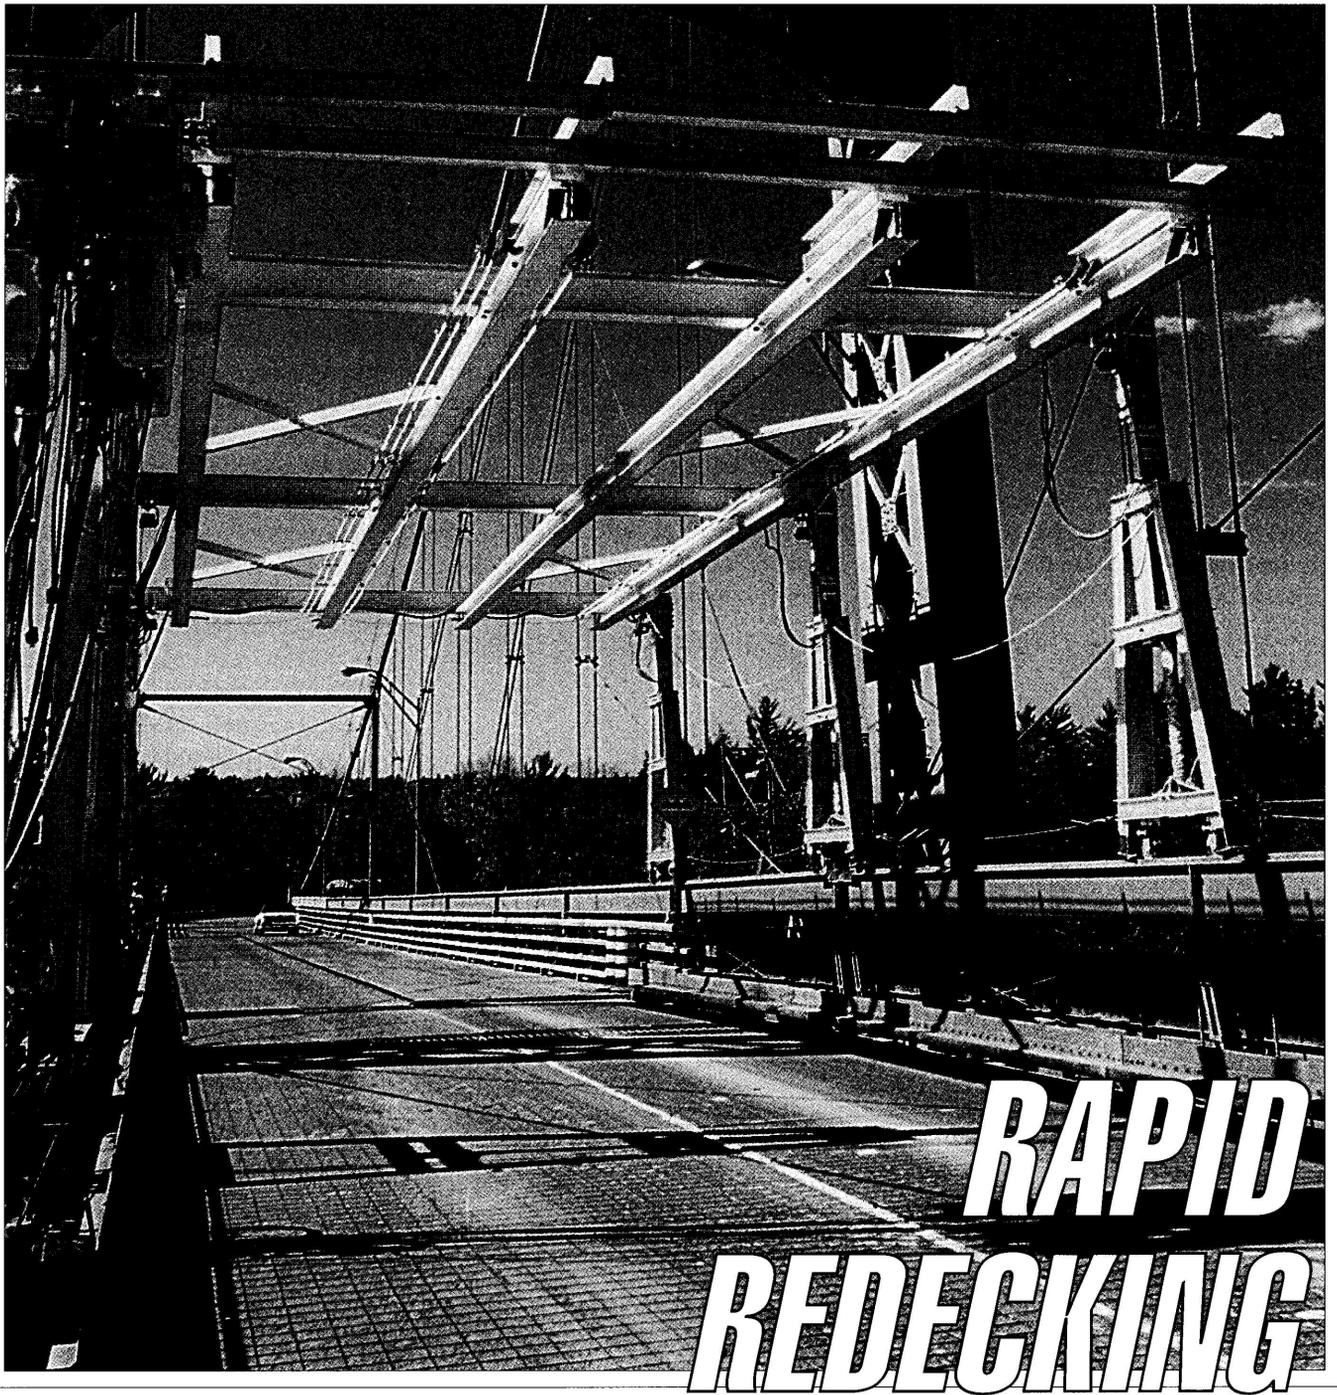
IN DAYTIME TRAFFIC FLOWED UNIMPEDED UNDER A PORTAL FRAME GANTRY USED IN THE EVENING TO LOWER NEW CONCRETE-FILLED STEEL GRID DECK PANELS INTO PLACE.

To lift out the old panels and lower the new ones into place, workers used a movable portal frame gantry system that rested on the structure during deck replacement. The frames spanned the roadway without reducing vertical or horizontal clearances on the structure. Rail guides provided lateral restrictions to the gantry wheels, ensuring the gantry moved parallel to the direction of the deck replacement.

Hydraulic rams capable of raising and lowering the frame supported the gantry's cross frame and made it possible to lift the deck panels vertically rather than in a plane perpendicular to the bridge deck. This reduced additional forces on the gantry. Three portal frame assemblies erected on the rails formed a 15-m-long gantry, the minimum required to remove one 7.6 m panel at a time and transfer it to a flatbed.

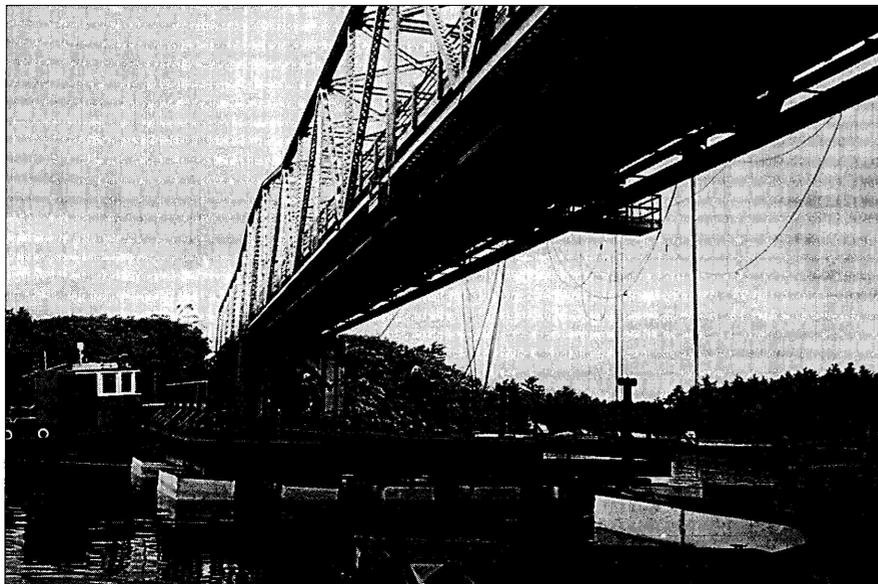
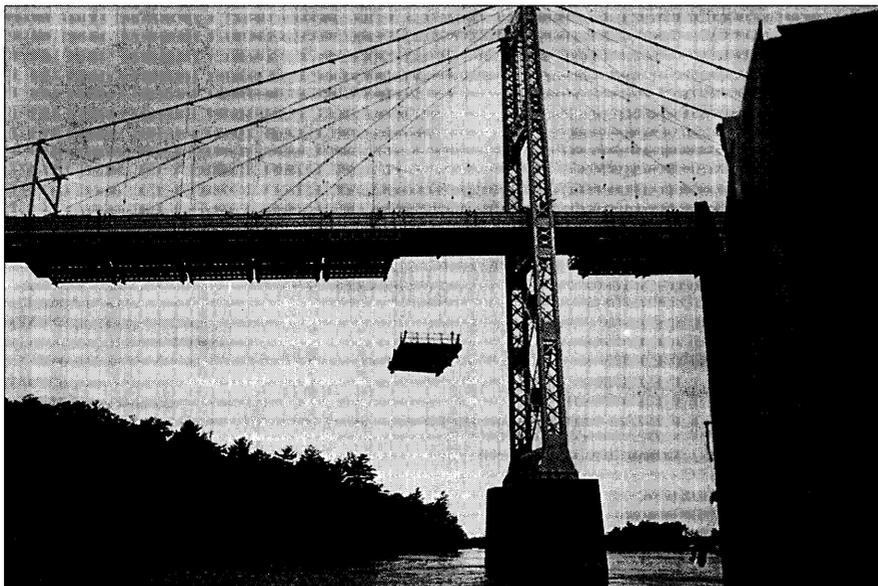
WORK PLATFORM SECTIONS WEIGHING 60 METRIC TONS EACH WERE FLOATED ON POLYSTYRENE, PULLED BY TUGBOAT BENEATH THE OVER-WATER SPANS (ABOVE) AND THEN LIFTED INTO PLACE (BELOW).

Installing work platform sections under the main span over the St. Lawrence River presented fabrication and erection problems. The 60-metric-ton sections, built at a small site just downstream of the bridge, were placed on polystyrene blocks, pulled into position under the center span by a tugboat and hoisted into place.

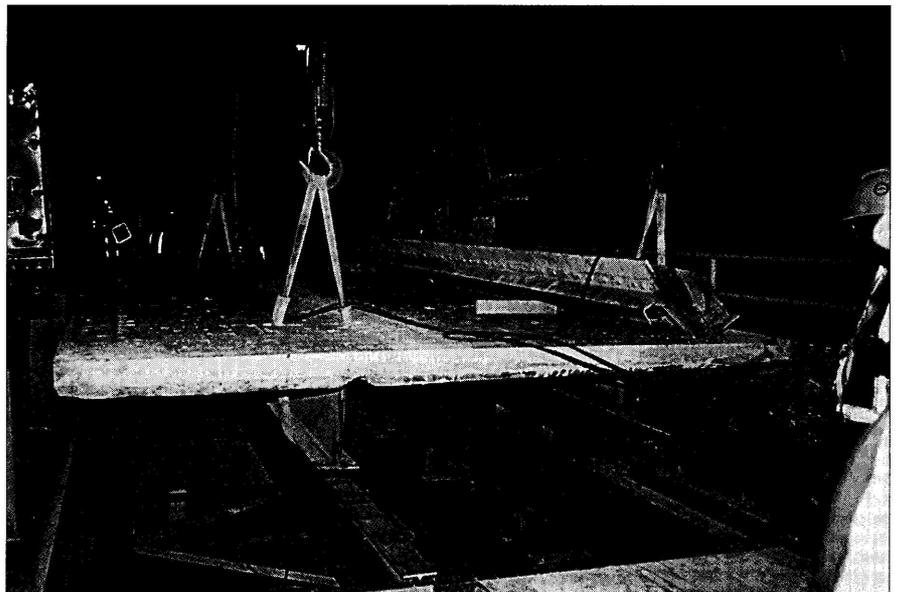
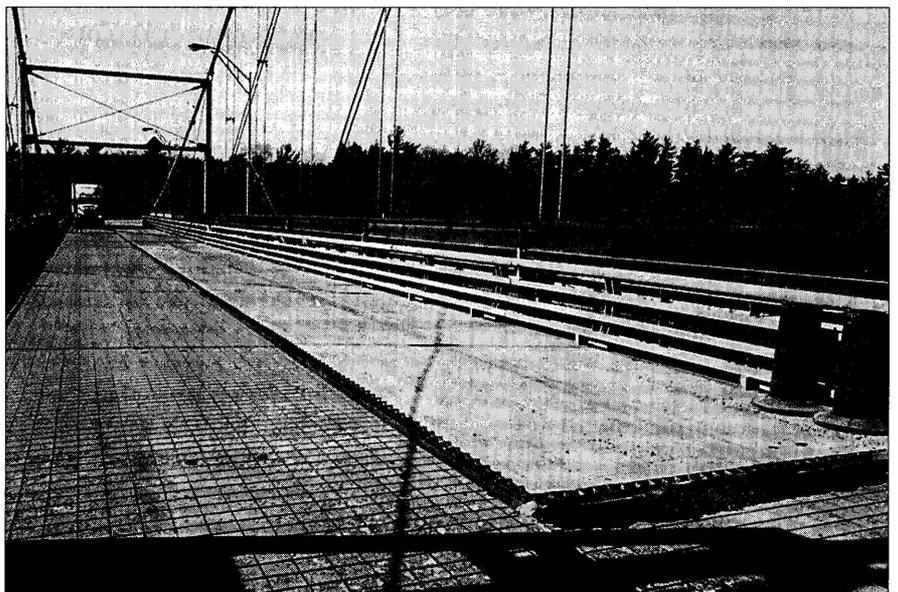
NIGHT CREWS WERE ABLE TO REPLACE 102 SUSPENSION SPAN DECK PANELS IN JUST 62 DAYS, BEATING CONSTRUCTION SCHEDULE REQUIREMENTS WHILE KEEPING BOTH LANES OPEN DURING THE DAY.

The original schedule called for replacing, on average, one to one and a half deck panels per night. The 102 suspension span panels were completed in 62 days, an average installation rate of nearly 1.65 panels per night.

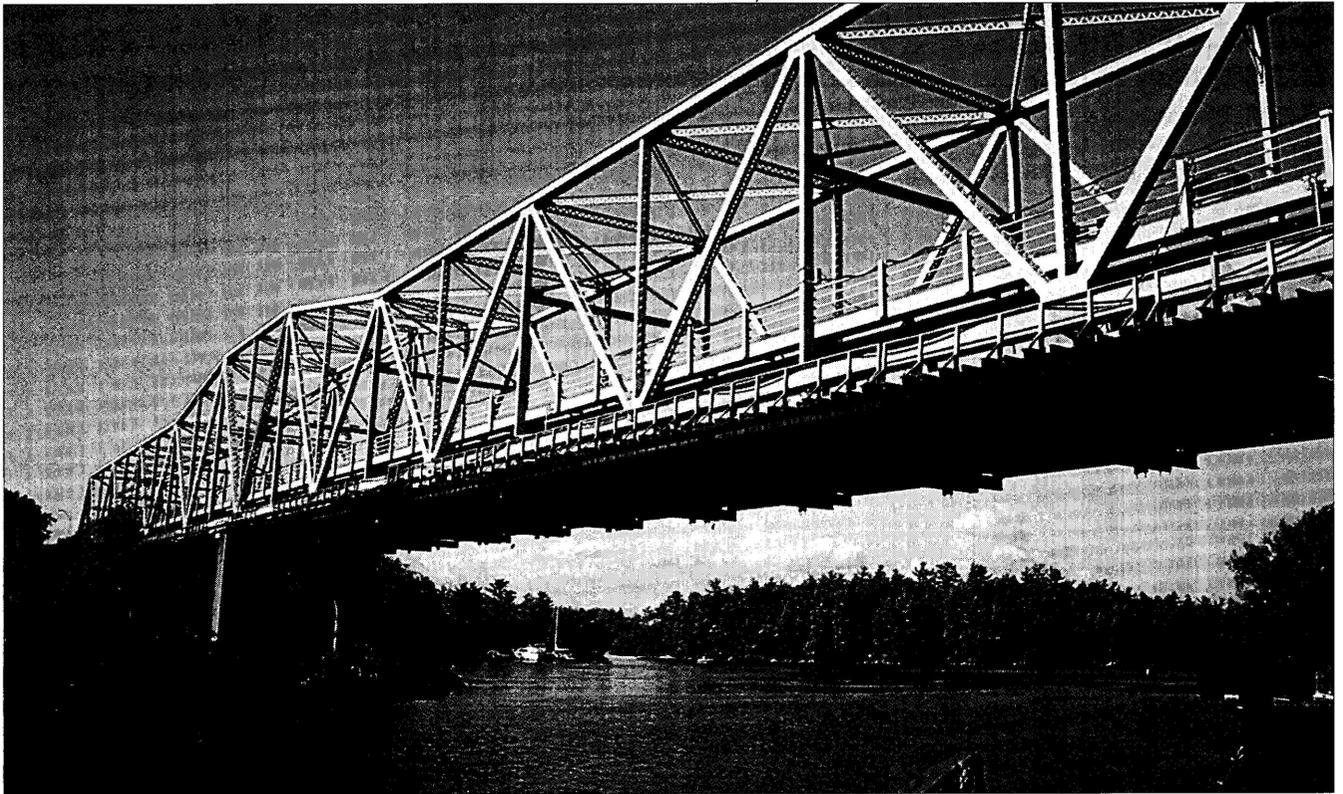
TRUSS MEMBERS PREVENTED CONTINUATION OF A MAINTENANCE WALKWAY ALONG THE SPAN'S EAST SIDE, AND FORCED USE OF AN OVERHEAD GANTRY SYSTEM TO MEET TRUCK CLEARANCE LIMITS. A RUBBER-TIRE-MOUNTED CRANE HANDLED DECK SECTIONS UNREACHABLE BY EITHER GANTRY SYSTEM.

Portal struts between the trusses prevented the portal frame gantry from providing the minimum vertical clearance for trucks on the Warren truss. An overhead gantry system built for that span consisted of I-beam rails erected beyond the limits of the new roadway all along the truss with a hoist frame attached to the bottom flange of the rails.

The end geometry of the truss members made certain deck sections at both ends unreachable by either gantry system. For these areas, the contractor employed a rubber-tire-mounted crane resting on deck panels on the adjacent, completed viaduct spans, ensuring the 50-metric-ton-capacity crane was supported by new construction. Crews carried out a complete replacement of the Warren truss deck 17 days ahead of schedule.
