Splicing Grid Reinforced Concrete Bridge Deck Panels Without Welding Using Conventional Rebar Methods

Abstract:

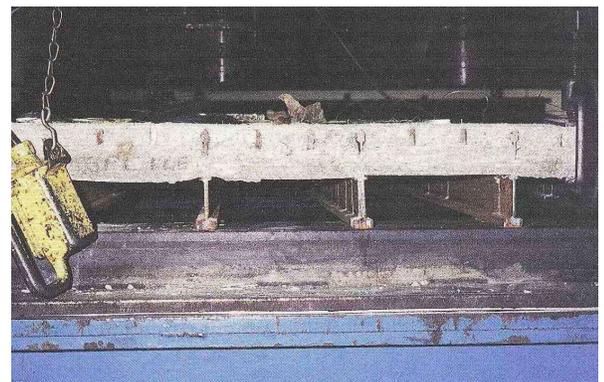
Panel being placed on supports

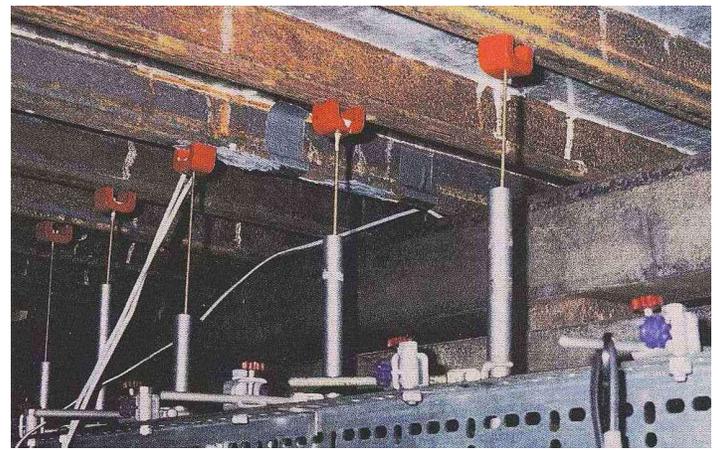
Deflection indicators under panel
