A STUDY OF THE
CONCRETE-FILLED STEEL GRID DECKS
IN OHIO

Donald H. Timmer, P.E.
Richland Engineering Ltd.
Mansfield, Ohio

The study was undertaken to determine the causes, types and extent of failures in concrete filled steel grid bridge decks. The study uncovered the phenomena dubbed "deck growth", that is caused by the rusting of individual steel grid I bars and is unique to filled grid decks. The increase in thickness or bulking of the I bars displaces adjacent concrete and develops compressive stresses in the concrete fill, in the cells located between I bars. In the initial stage of deck growth, the compression of the fill tends to close voids and capillaries in the concrete and decrease the amount of moisture that can reach the rusting surfaces. The resulting slow down or halting of deck growth is another phenomena dubbed "stress balance." If deck growth continues beyond the initial stage, it will involve the progressive failure of the deck and will lead to the breakup of the fill and grid, a critical failure in the bridge superstructure and/or severe damage to the bridge substructure. The study includes the survey of the 60 bridges in Ohio that have, or recently have had fi

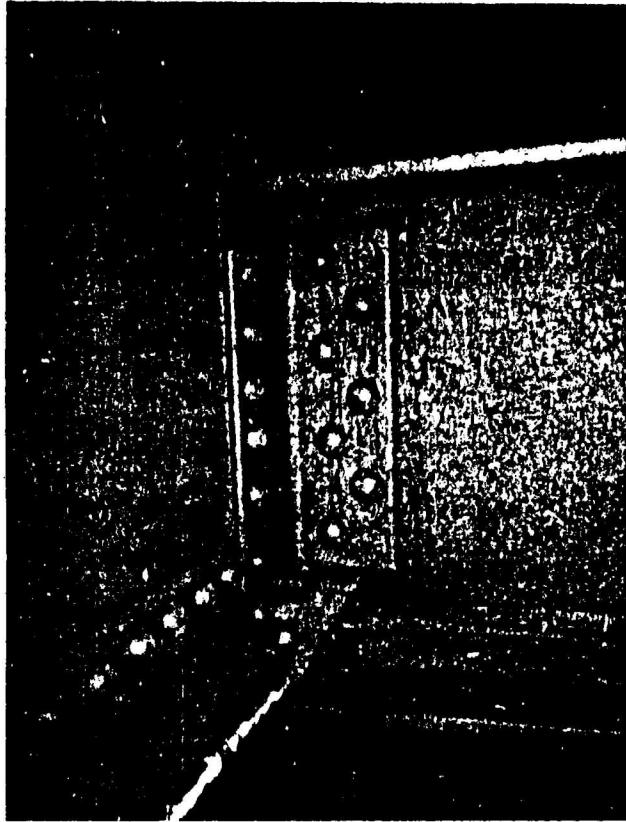
Continued deck growth at closing deck joints can cause damage and failure to the joint support members (Figure 11) and after closing, damage to substructure bridge seats that support fixed shoes (Figures 12 and 13).

webs to tear (Figure 11), the deck to buckle and the superstructure beams to pull free from the abutments, as is shown in Figures 12 and 13.

Figure 12. Abutment bridge seats pulled free - Fixed bearing, Bridge 26. (1978).

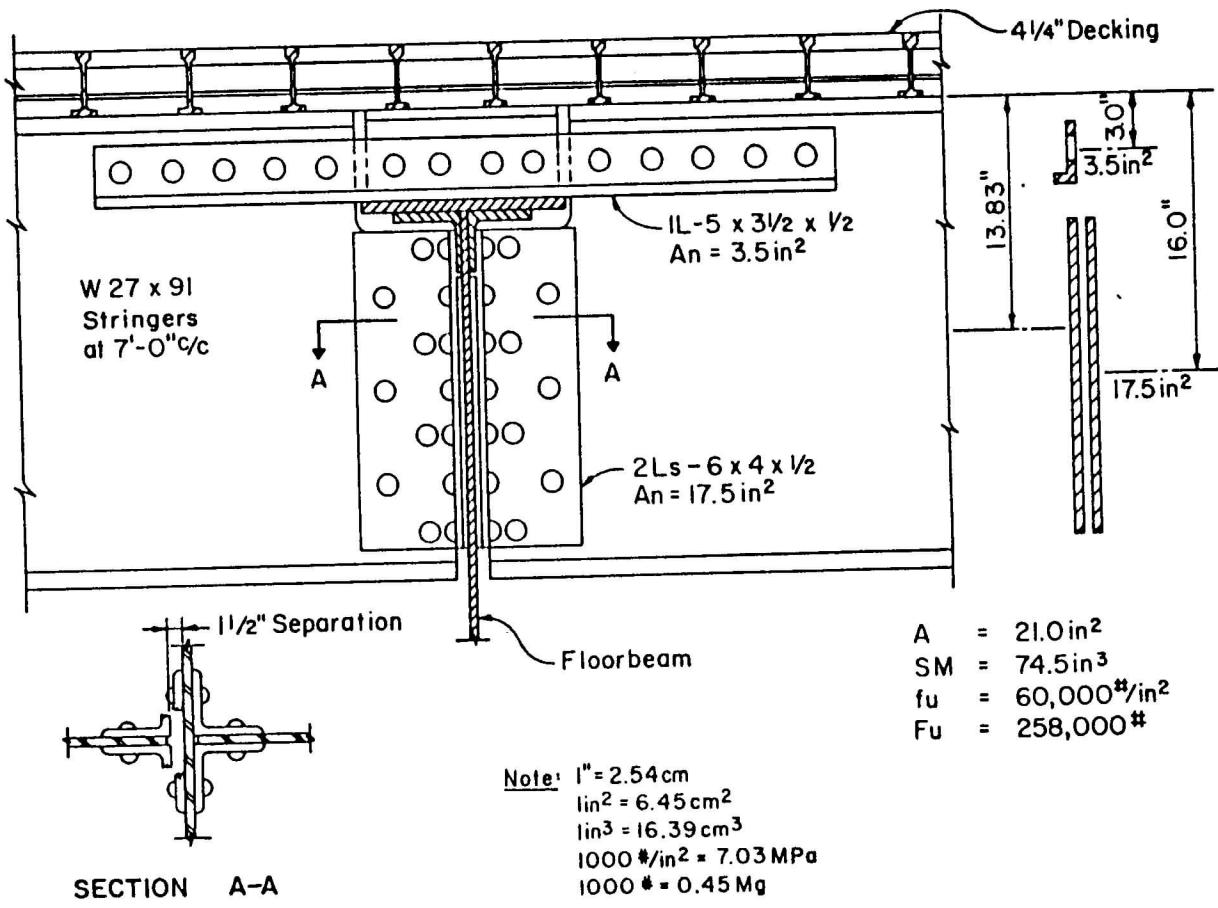
(The welds between the decking and the stringers held the stringers from falling to the roadway below.) The forces generated by deck growth had to exceed 1000 psi (7 MPa) in the deck concrete in order to provide the 250,000sf (113 Mg) thrust at the tops of the stringers needed to sever the connection angles, as shown in Figure 18. Emergency repairs were performed to replace the damaged angles. Later investigation found

Figure 18. Stringer to floorbeam connection, Bridge 42.
